Safeguarding of the Portuguese Heritage: the Case Study of Safi Cathedral, Morocco

ABSTRACT: The city of Safi is located in the West African coast, about 150 km from the city of Marrakesh and 300 km south of Casablanca, Morocco. The Cathedral of Safi was the first Portuguese cathedral outside Portugal during the Expansion period and it is the most important example of the non-military Manueline architecture that still remains outside Portugal. The construction of the cathedral started during the decade of 1520. It was originally a three nave church and is believed to be similar to other temples of the time such as the Funchal or Guarda Cathedrals. During its history, the cathedral was occupied by Muslims who eliminated the naves, leaving only the main altar, one lateral chapel and an outside wall. The space of the naves was used to add several residential buildings and they turned the altar in a bathhouse for women (hammam in Arab). The altar, crowned by a ribbed vault, the lateral chapel whose roof, also vaulted, is missing and one alone standing external wall are the only original parts of the structure that are left. The Cathedral will be soon submitted to a structural interven

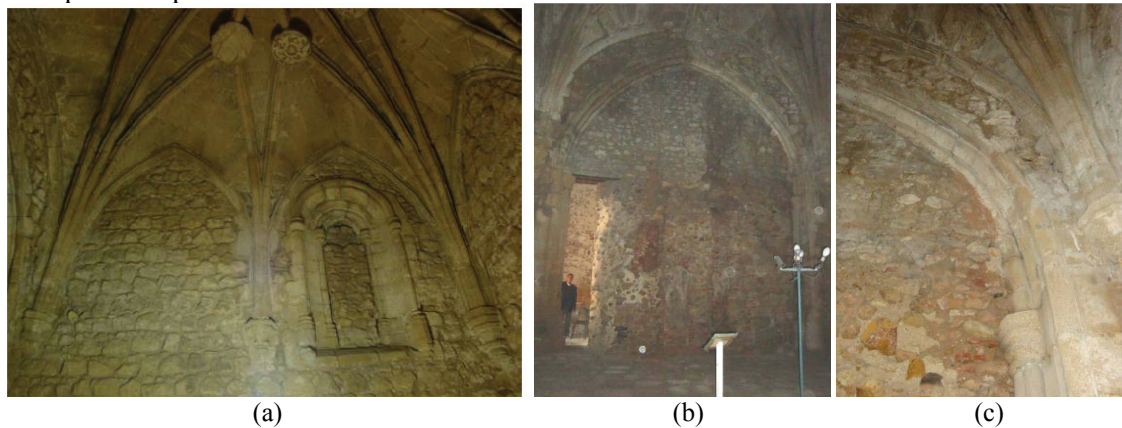
Figure 4: Main chapel: (a) elevation in south-west direction; (b) inner view in south-west direction (former hammam); and (c) detail of encounter of pointed arch, diagonal rib and partition wall of south west elevation.

Figure 4 shows some general views of the inside of the Manueline ruins [2]. As it can be observed in Figure 4a, the structure is made of two types of stone masonry. The walls are in general of masonry with limestone units and lime mortar joints. Nevertheless, several joints with cement mortar could be observed, which correspond to recent reparation works. The vault of the main chapel has ribs made of local stone with joints of poor lime mortar. The remaining wall corresponds to porous limestone.

The inner space, shown in Figure 4 corresponds to the place where the hammam was installed after the Portuguese left Safi. The narrow door that can be observed on the left side, leads to the lateral chapel and to the present access of the cathedral. On Figure 4 also modifications introduced by the Muslim community can be observed. This modification correspond to the closing of the windows with masonry, as shown in Figure 4a. Also the space beneath the arch of the north-west elevation was closed with a masonry wall, as seen in Figure 4b and c. This part is believed to have been completely open towards the main corps of the ancient church. A detail of the encounter of the arch, the column and the infill wall can be observed in Figure 4c.

The joints which present cementitious mortar should be removed and substituted by lime mortar, similar to the original one. This will eliminate compatibility problems and permit a more homogeneous behavior of the structure.

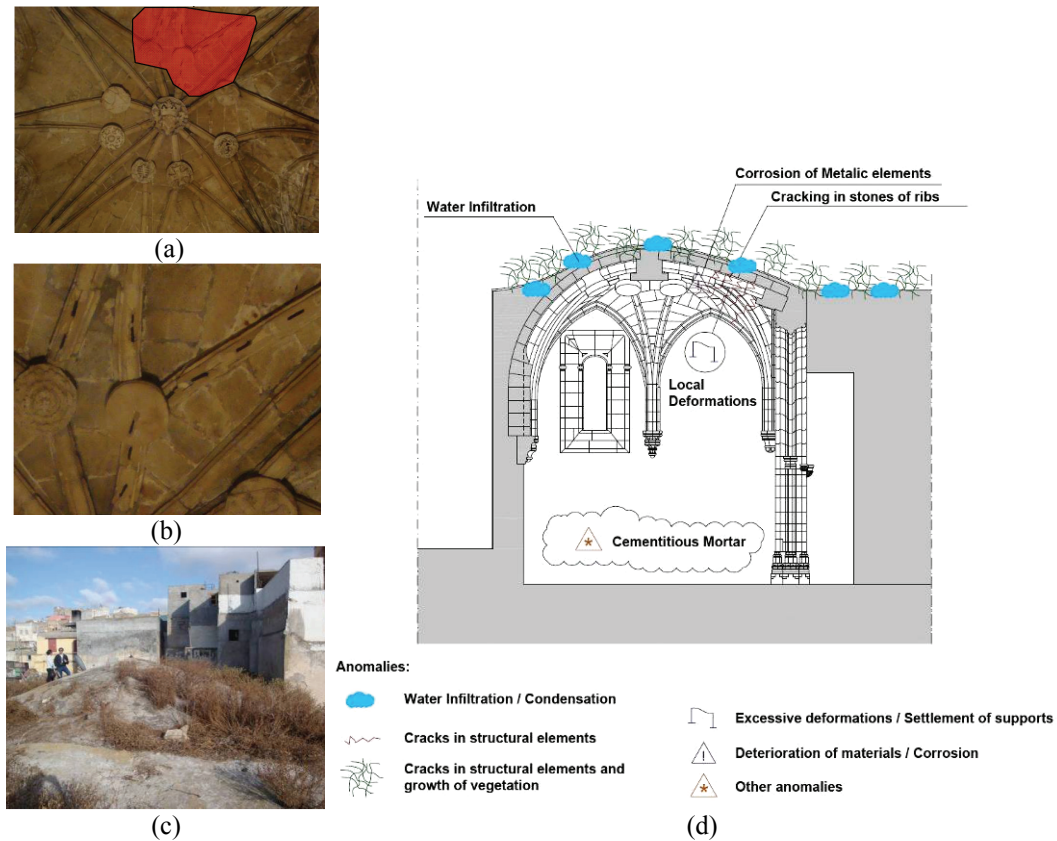
Figure 7: Main chapel vault: (a) general view with deflected zone (red); (b) detail of metallic strengthening works; (c) extrados of the vault with vegetation that induces cracks in the cover material; and (d) the damage map.

During the visual inspection no relevant cracks in the masonry walls which are going to be maintained by the new rehabilitation project were detected. Regarding the vault of the main chapel, a zone with large vertical displacements was observed (see Figure 7a). This zone limits with an old perforation of the vault which was introduced for the hammam chimney.

The existence of a chimney which crossed the vault exactly at one of the main-stones of the ribs was already documented in 1929 by the General Head Office of Arts and Historical Monuments of France [1]. The consequence of this alteration is the opening of some joints of the ribs and the opening of cracks in stones, justifying the earlier insertion of metal clamps as reinforcement. The deformed zone (marked in red) and the metallic reinforcement are shown in Figure 7b. However, the corrosion of the clamps has provoked the expansion of the metallic elements, generating new cracks and aggravating the stability of that zone of the vault. It can also be observed that the ribs of the vault do not present a perfect symmetry. This is most probably a construction defect.

The vault is covered from the outside with a cement layer that has large cracks, in which even vegetation grows, see Figure 7c. These defects permit the infiltration of water, washing out fine material and deteriorating the lime mortar of joints of the vault and walls beneath. Finally, Figure 7d summarizes the anomalies of the main chapel which were previously mentioned.

The extrados of the main altar vault has been covered by a cement layer. This layer presents large cracks which host vegetation. These cracks also permit the filtration of water and the subsequent washing out of fine material and degradation of mortar of the vault and supporting walls. Humidity was detected in the environment of the main chapel, but no efflorescence on walls nor pavement were spotted during the visual inspection, which could indicate high salt content in the subsoil. To avoid the deterioration of the structural members, it is recommended to eliminate the vegetation in the cracks and to protect meanwhile the extrados of the vault and the upper part of the walls from water until a definite solution is adopted. The restoration project proposes the solution for this problem for the long term situation.

The consolidation of the arch of the main chapel is of particular difficulty, since it presents a pronounced deformation in the middle span, being probably supported by the masonry wall built under the arch to create the hammam. The demolition of this wall will be monitored, specially the movements of the vault. The displacements will be compared with the FE model, allowing an even guarantee safety during the works.

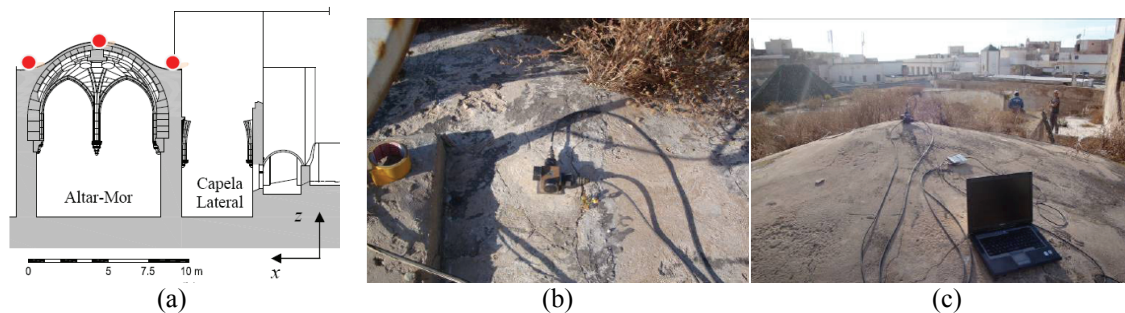
Figure 8: Dynamic tests: (a) location of accelerometers; (b) accelerometers on the perimeter of the vault; and (c) accelerometer on top of the vault.

The dynamic test consisted in the measurement of accelerations in different points of the extrados. Accelerometers were installed with the configuration shown in Figure 8. The source of vibration was environmental vibrations (wind, traffic pedestrians, etc) and which has the characteristics of white noise. The vibrations were recorded for 10 min with a sample rate of 200 Hz.

The acceleration records were then processed through an output-only method, since no controlled vibration was induced to the structure. The data processing was done with a stochastic method known as Stochastic Subspace Identification (SSI) method. The result shows that the frequencies of the first 10 modes range from 5.2 to 11.7 Hz. Damping ratio ranges from 0.9% to 4.7%, with an average value equal to 3.2%.

The results of the dynamic tests reveal that the analyzed structure presents high natural frequencies. This is probably due to the support of the surrounding constructions next to the main altar.

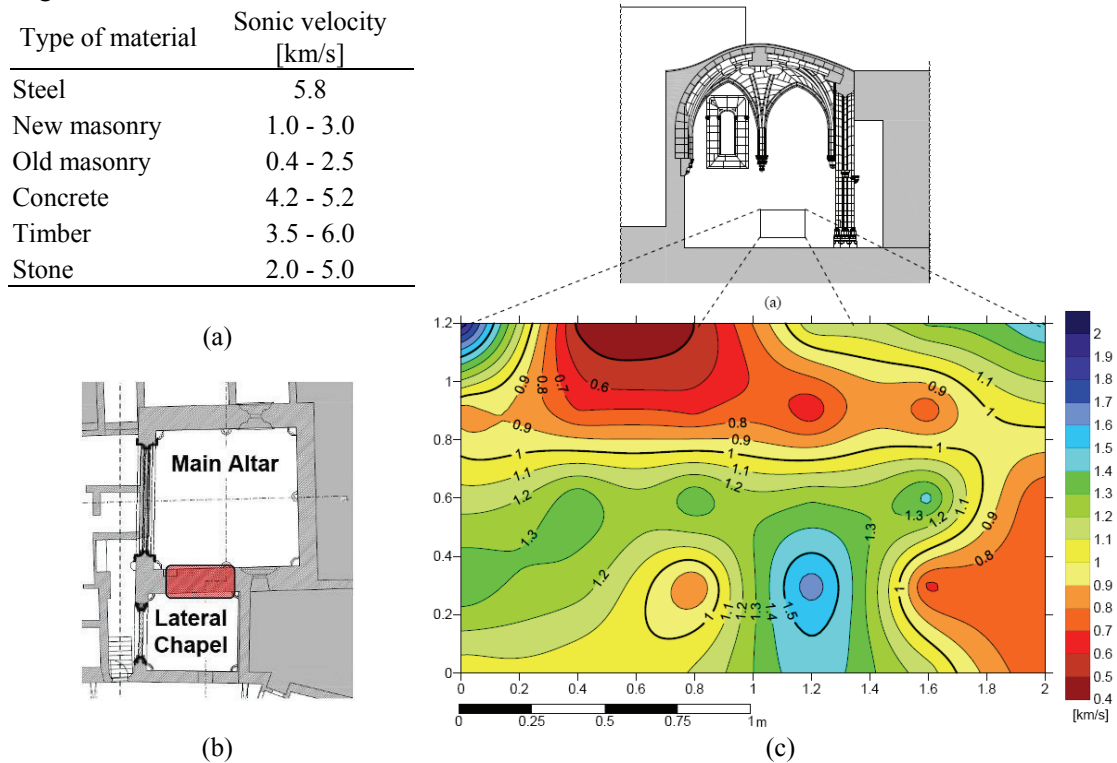
Figure 9: Sonic test of the wall: (a) common values for sonic velocities; (b) location of measurement grid; and (c) sonic velocity map.

To analyze the state of conservation of the walls, an area of 2.0×1.5 m and 50 cm over the ground floor was chosen. Figure 9b shows the location where the sonic test was carried out. The velocities were measured on a 40 cm horizontal and 30 cm vertical mesh. The transducers

Figure 9c shows a velocity map of the mean velocities of propagation of the wall. The velocities range from 0.5 to 2.0 km/s, with a mean value of 1.1 km/s. The mean value corresponds to an expected value for old masonry walls. Nevertheless the difference between the maximum and minimum values indicates the existence of cavities inside the wall. This fact also indicates that the wall corresponds to a three leaf wall with smaller stones or gravel in its center.

The sonic tests and the perforation of the lateral wall revealed the existence of voids inside the masonry wall which divides the lateral chapel and the main one. These voids could be filled through injection grout of lime mortar, to consolidate the walls. The zones have to be determined previously, since an uncontrolled grouting is undesirable and very probable because of the similar masonry of the adjacent structures.
